KENSICO DAM  
WESTCHESTER COUNTY NEW YORK  
INVENTORY NO. 51

PHASE I INSPECTION REPORT  
NATIONAL DAM SAFETY PROGRAM

Prepared by: NEW YORK DISTRICT CORPS OF ENGINEERS  
For: THE STATE OF NEW YORK  
Date: MAY 1978

Name of Dam: KENSICO DAM  
State Located: NEW YORK STATE  
County Located: WESTCHESTER COUNTY  
Stream: BRONX RIVER  
Date of Inspection: 12 JANUARY 1978

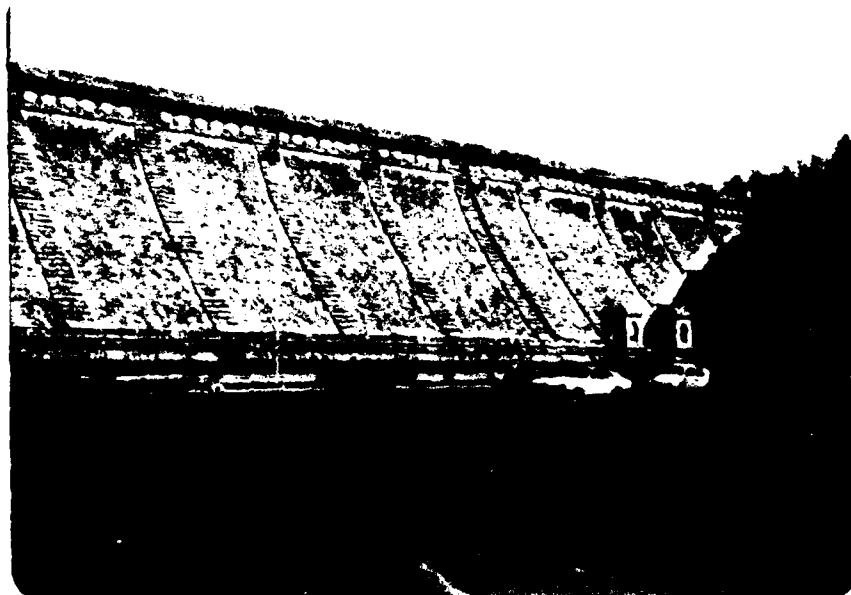
DOWNSTREAM FACE KENSICO DAM

b. Dam - The dam appears to conform to the available drawings with respect to the geometry of the structure. No seepage was noted at the downstream face of the dam or at the abutments and only very minor seepage was noted in the drainage wells and inspection galleries. A portion of the water noted in the drainage wells and observation galleries originates as surface water on the roadway above the dam, being transmitted to the drainage wells through drop inlets and manholes. There is no method for separating this surface water from actual seepage through the masonry and joints of the dam. Total volume of water passing the lower gallery has been measured at 2000 gallons per day. No visual signs of misalignment or structural cracking were observed on either the exterior of the dam or in the inspection galleries or drainage wells. Concrete exposed in the inspection galleries was in excellent condition, no significant cracking or spalling was observed. The downstream face of cut granite is in excellent condition and exhibits no sign of seepage. On the upstream face of the dam the original concrete blocks were found to have deteriorated, probably due to saturation and subsequent freeze and thaw. The deteriorated concrete was found to extend 18-20 inches into the face. Deteriorated concrete was removed and the face repaired and shotcreted from the top of the dam to about elevation 335 feet MSL over the entire length of the dam.

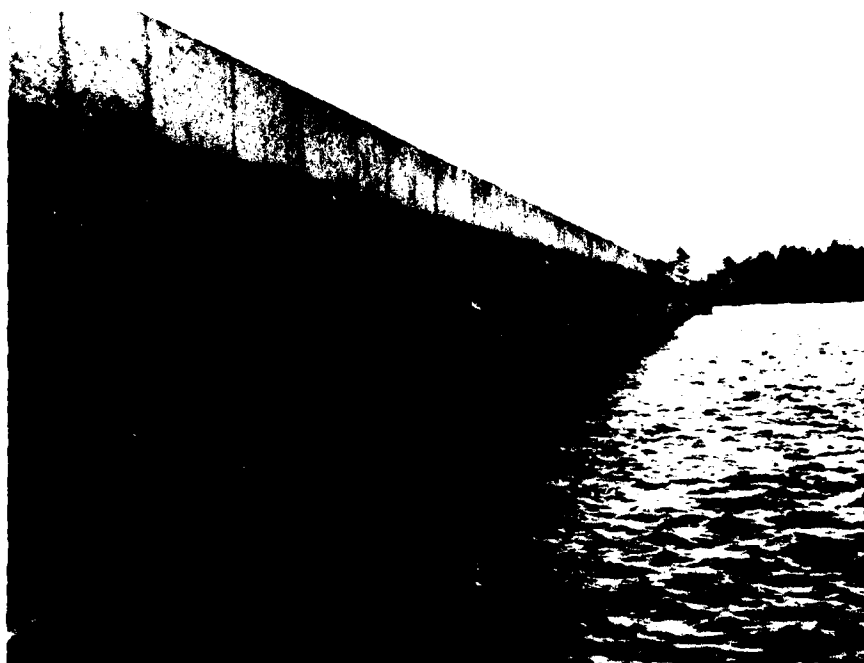
UPSTREAM FACE KENSICO DAM

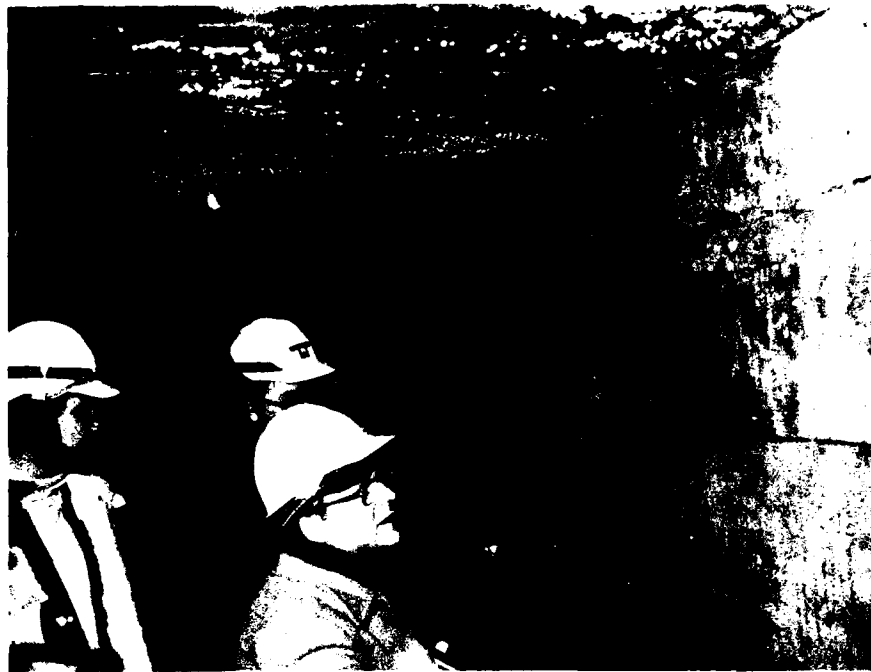
CRACK AT UPPER GALLERY

VISUAL EXAMINATION OF	OBSERVATIONS	REMARKS OR RECOMMENDATIONS
SURFACE CRACKS CONCRETE SURFACES	None observed	
STRUCTURAL CRACKING	None except several horizontal longitudinal fractures in side wall of upper inspection gallery (primarily meeting Jts of conc. pieces)	Fractures which are at approx. 60-70°, are not significant.
VERTICAL AND HORIZONTAL ALIGNMENT	No misalignment is evident	
MONOLITH JOINTS	No apparent movement	
CONSTRUCTION JOINTS	None observed	
PLANT GAGE OR RECORDER	CRACKING

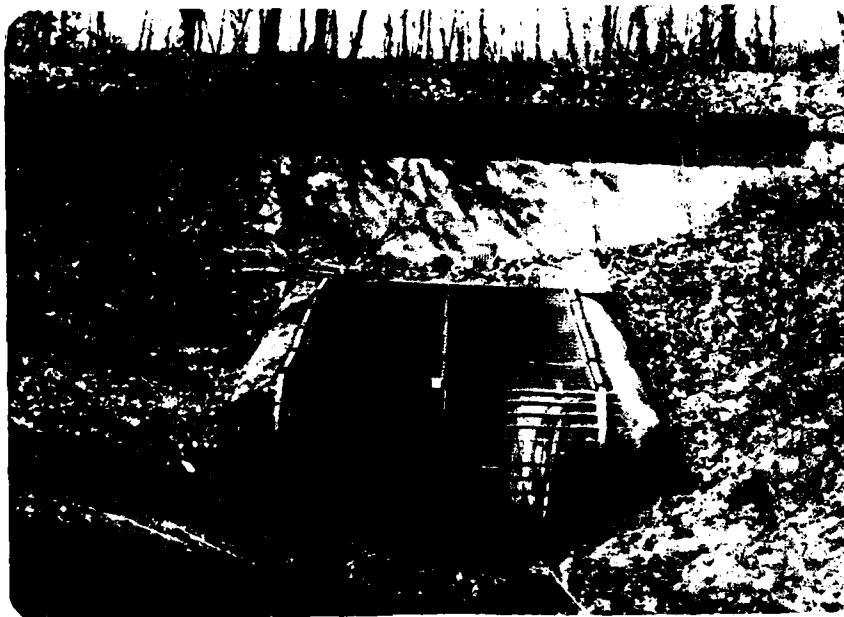
ENTRANCE TO OUTLET TUNNEL  
DOWNSTREAM CHANNEL KENSICO SPILLWAY
